AVIATION INVESTIGATION REPORT

A03O0273

RUNWAY EXCURSION

GULFSTREAM AEROSPACE LP ASTRA SPX C-GSSS

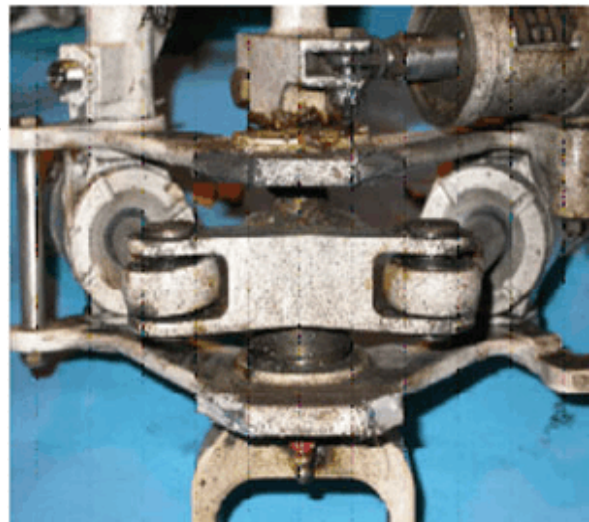
Examination of the aircraft revealed that the nose landing gear steering assembly upper and lower attachment brackets had failed near the attachment to the aircraft bulkhead. The left steering actuator was found fully extended and the right steering actuator was found fully retracted; this corresponds to a full-left steering input. The entire steering assembly was rotated and jammed against the right side of the nose landing gear bay, beyond the normal steering range for the nose landing gear.

The steering assembly (see Photo 1) comprises an upper and lower attachment bracket, a left and right steering actuator, and a shaft with a universal joint to mate to the nose landing gear. The brackets are bolted together at four points using nuts and bolts with a spacer to maintain separation. The entire steering assembly is then bolted to the aircraft at the nose landing gear bay aft bulkhead.

Photo 1. Rear view of steering assembly removed from the aircraft

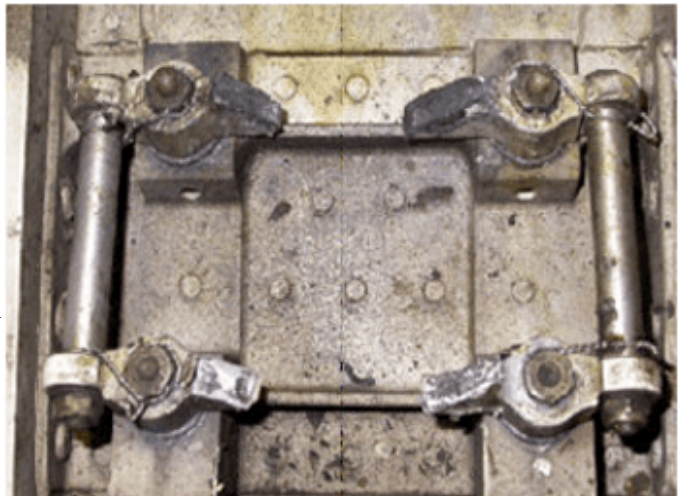
There was fretting² found on the mating surfaces of the upper and lower brackets at the attachment to the aircraft bulkhead (see Photo 2). The upper bracket fracture surfaces were heavily contaminated with blackened Skydrol hydraulic fluid, and had a polished appearance. As well, the paint around the fracture surfaces was softened and blistered in much the same manner as a painted surface with paint stripper applied. By comparison, the lower bracket fracture surfaces were clean and dull in appearance, and the paint showed no signs of softening or blistering. Both the upper and lower bracket fracture surfaces had smearing damage from the fracture surfaces impacting each other. The entire steering assembly was forwarded to the Transportation Safety Board (TSB) Engineering Branch Laboratory for further examination.

Photo 2. Upper and lower attachments on aft bulkhead

Laboratory examination showed there was no indication of fatigue cracking on any of the fractured surfaces and all of the fracture surfaces were representative of overstress failures. A test was conducted to see how long it would take for the paint to start blistering if contaminated with Skydrol hydraulic fluid. This consisted of scratching through the paint to the metal on a cleaned portion of the attachment bracket. This would be representative of a typical crack in the paint at a fracture site. The area was then contaminated with Skydrol hydraulic fluid; it took approximately three weeks for the test area to show any signs of paint blistering.

It was concluded that the top attachment bracket was overstressed and failed at sometime prior to the occurrence. It was not possible to determine when the top attachment bracket failed; however, the combination of the polished fracture surfaces, the blackened Skydrol contamination on these surfaces, and the softened paint around the fractures are indicative of an old failure that had been working or rubbing together for sometime. Additionally, the fretting found on the mating surfaces of the upper and lower attachment brackets supports this analysis. The fretting indicates that the attachments to the aircraft were moving due to the transfer of steering loads to the lower brackets. The clean, dull fracture surfaces of the lower bracket were overload failures at the time of the occurrence.

It is most likely that the occurrence aircraft was towed beyond the steering limits with the scissors connected at some time prior to the occurrence. This resulted in the fracture of the upper bracket but did not immediately affect the handling characteristics of the aircraft. The nosewheel shimmy on landing in Toronto stressed the lower attachment to the point that it failed in overload. With the steering assembly free to move, inputs to the steering tiller would be ineffective in maintaining directional control of the aircraft.

On 21 October 2003, the State of Israel, Ministry of Transportation, Civil Aviation Administration, issued Airworthiness Directive (AD) 32-03-10-05, effective 28 October 2003, requiring a one-time inspection of the upper and lower steering assembly brackets within 50 flight hours or 25 landings, whichever comes first. This AD was endorsed by Transport Canada on 17 November 2003.

On 24 October 2003, Gulfstream Aerospace LP issued Alert Mandatory SB 100-32A-275, titled "Nosewheel Steering - Inspection of Upper and Lower Steering Assembly Brackets," which called for a one-time inspection of the brackets and an inspection of the nose-centring spring. This was further revised to Revision Number 1 on 24 December 2003. The visual inspection changed to eddy current and the non-destructive-testing (NDT) inspection became part of the periodical inspection of Aircraft Maintenance Manual (AMM) CH-5 every 250 hours. (Refer to 5-24-01, Rev-9, dated 30 December 2003). Also, it should be noted that SB 1125-11-181 (mentioned above) was published as Revision Number 1 on 24 December 2003 and changed from Recommended to Mandatory.

On 3 October 2003, Partner Jet issued Operational Memo 02-25, reminding pilots that the steering scissors are to be disconnected after flight to ensure that the aircraft is not towed with the scissors connected. Pilots are also advised they may have to remind ground handlers that the aircraft is not to be towed with the scissors connected. In addition, the company complied with the previous SBs mentioned in this report.
